Unique Issues, Challenges & Needs of a Coral Atoll Airport in Operating and Achieving Safety Compliance

**FAA Western-Pacific Region
4th Annual Airports Conference
Westin Los Angeles Airport Hotel
Los Angeles - 6-8 May 2008**

Experiences from Majuro International Airport Republic of the Marshall Islands

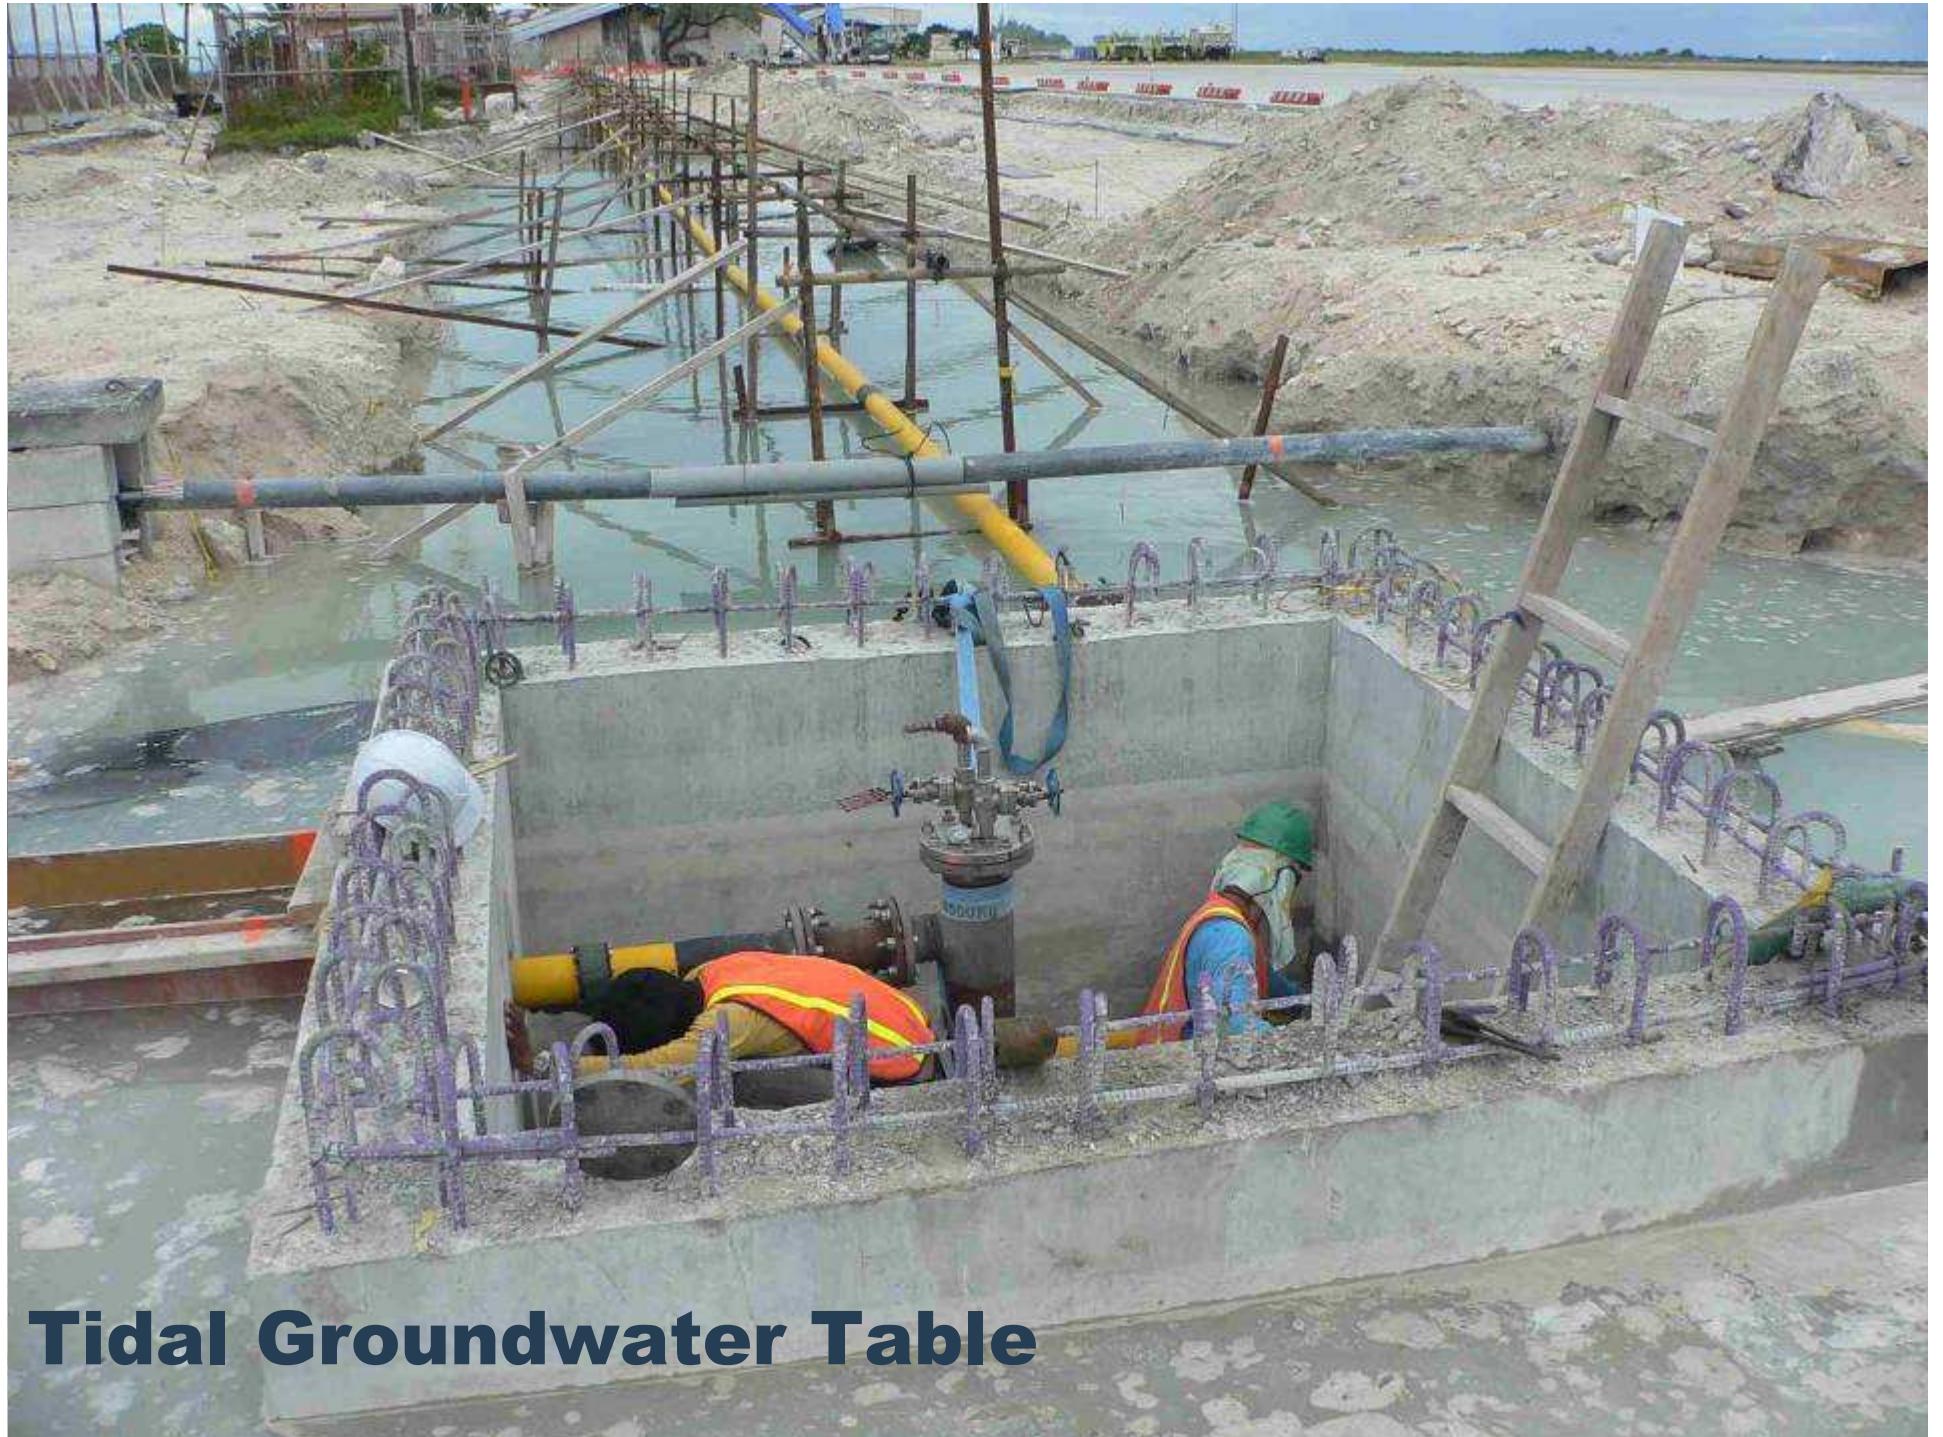
Tidal Groundwater Table

- Permitting
- Coral aggregates
- Fragile coral reef
- Construction waste
- Highly corrosive
- Humidity damage
- Flooding
